# *Little Goose Dam*

## *Radial Gate Inspection and Testing*

US Army Corps of Engineers, Walla Walla District

13. ABSTRACT (Maximum 200 words) This report is an evaluation of the overall condition of the spillway tainter gates at Little Goose Lock and Dam, Snake River Washington.				
20030313 194

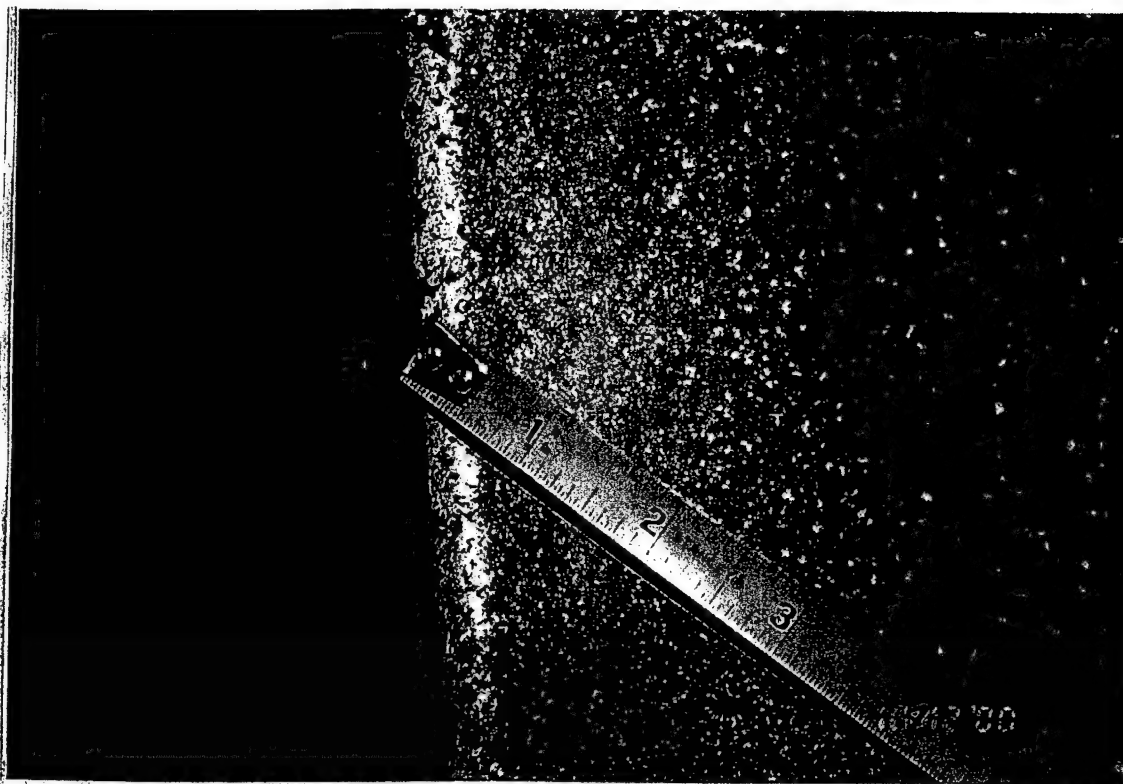
Bottom horizontal girder, left side.  
Standing water, no drainage between  
multiple stiffeners, typical. Side seal  
leak.

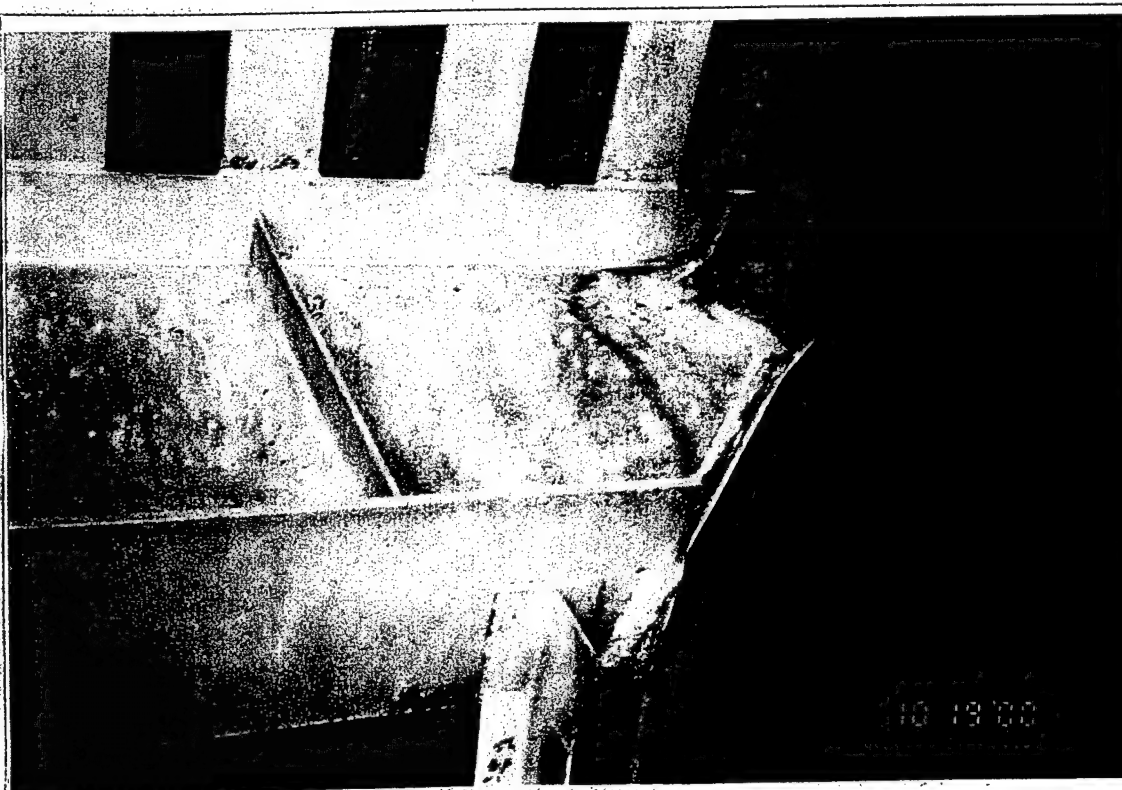
Downstream side of skin plate.  
Evidence of previous repairs.

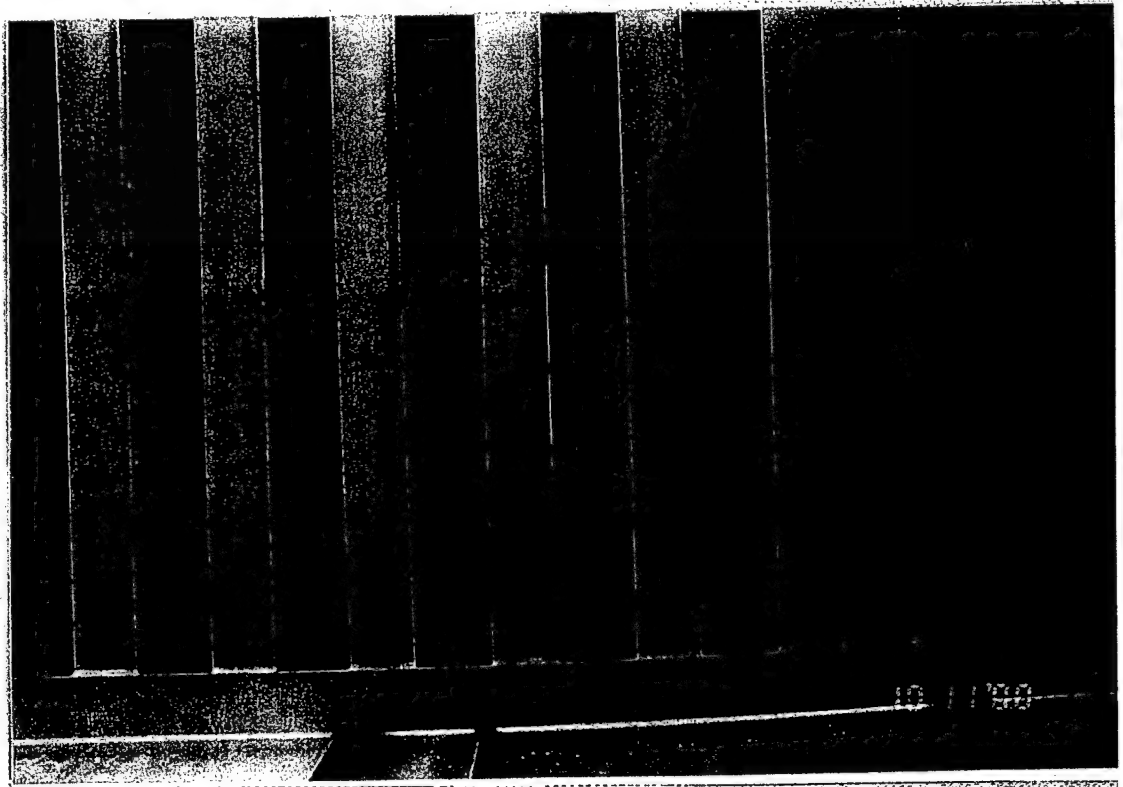
Downstream side of skin plate, left  
side of gate, above top horiz. girder.  
Peeling paint, light corrosion.  
Appears to be possible paint blister  
due to upstream skin plate welding.

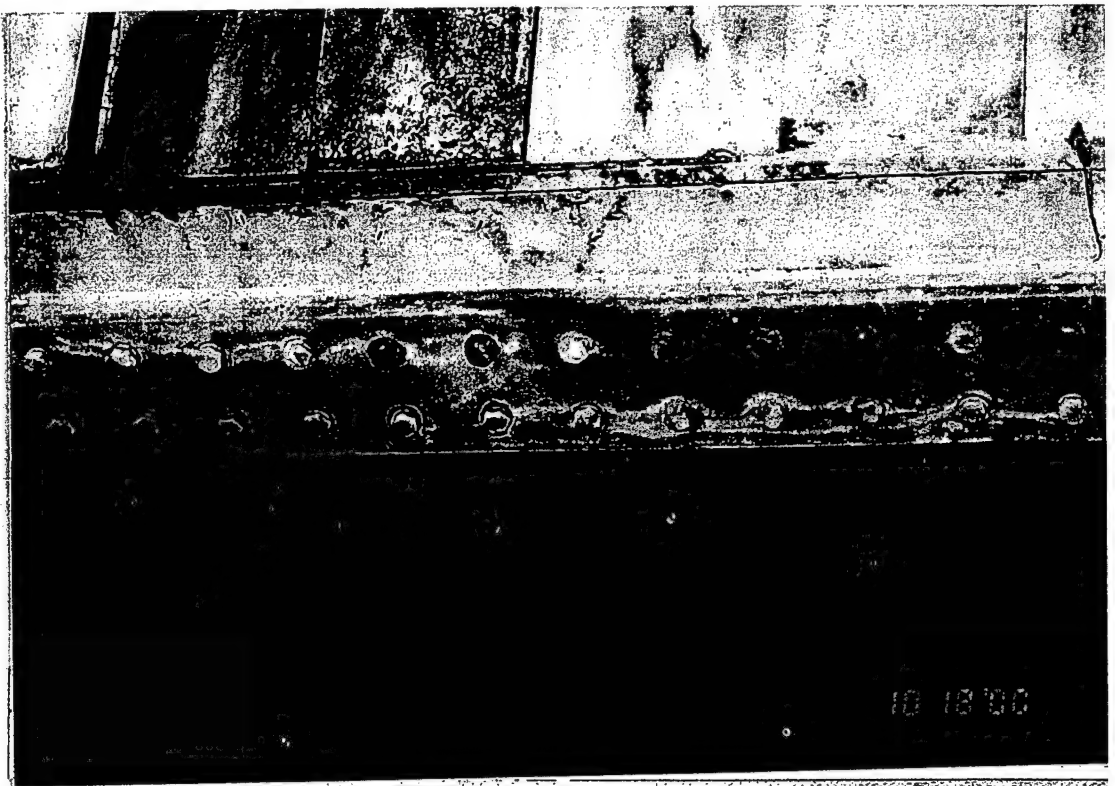
**Gate 5**  
Top of right hoist connection. Light  
corrosion on lifting lugs and plates.

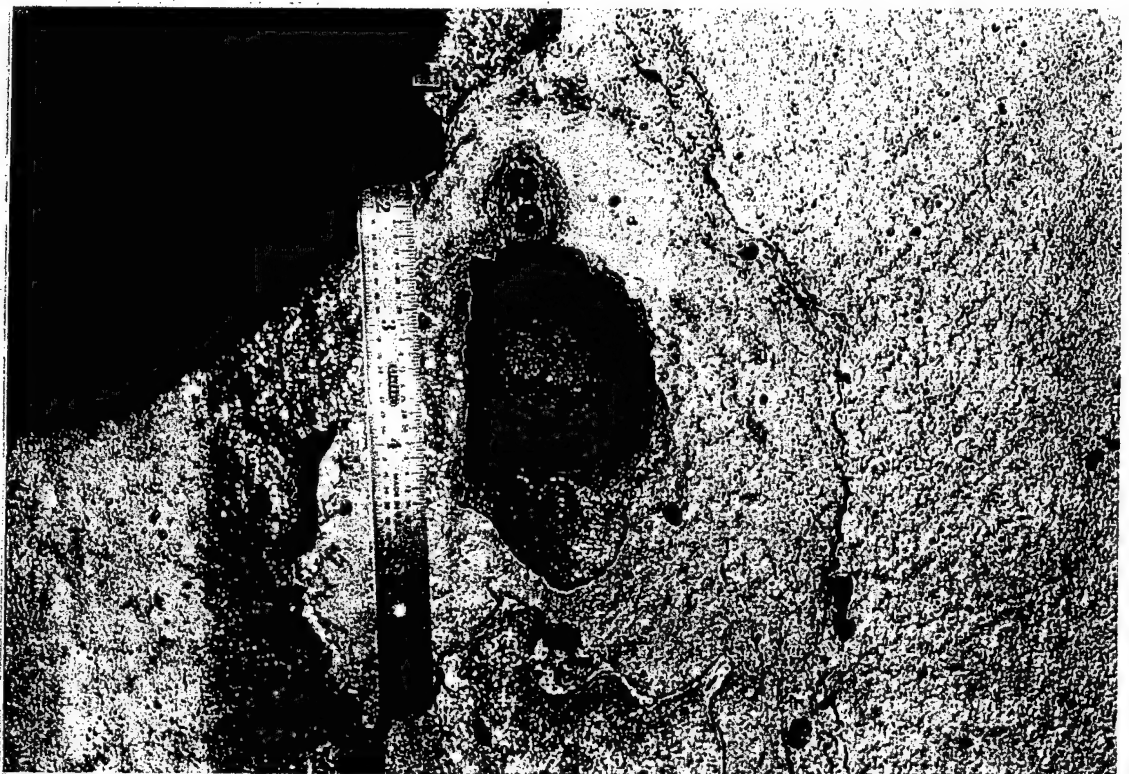
5-21

**Gate 5**  
Waterblasting and typical skin plate  
condition. Minimal pitting on skin  
plate (except for wear plates).

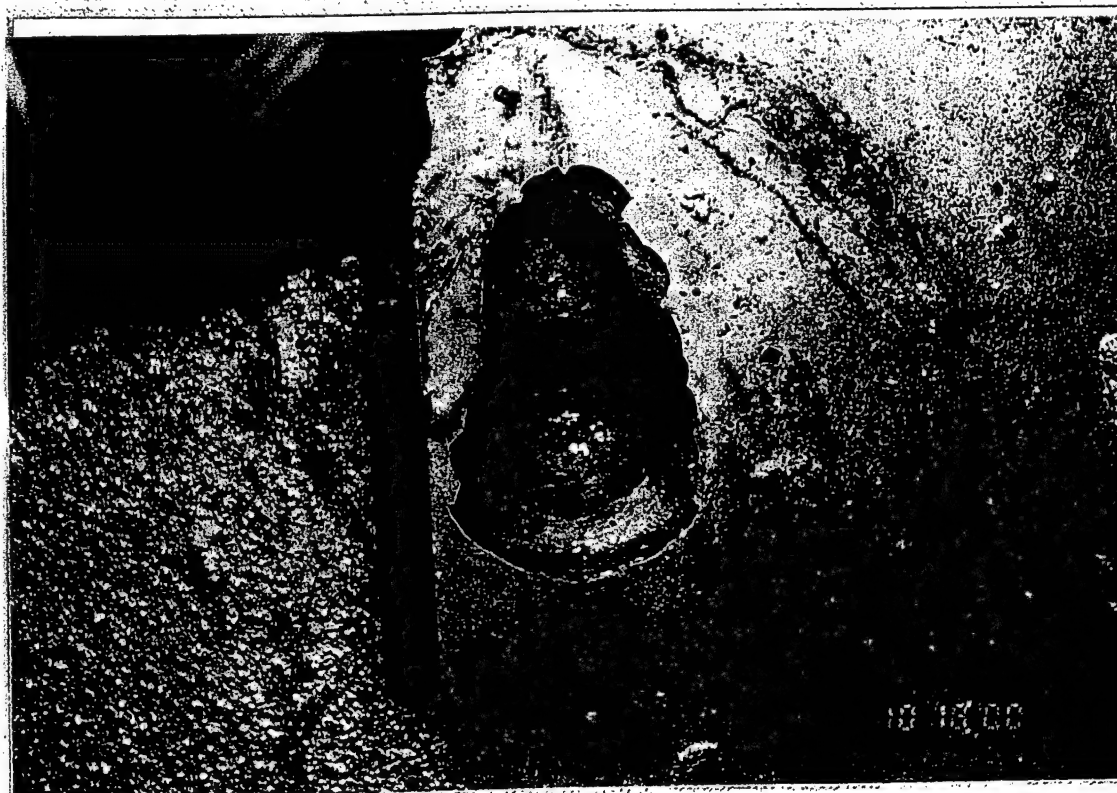
Heavy pitting on wear plate, typical.

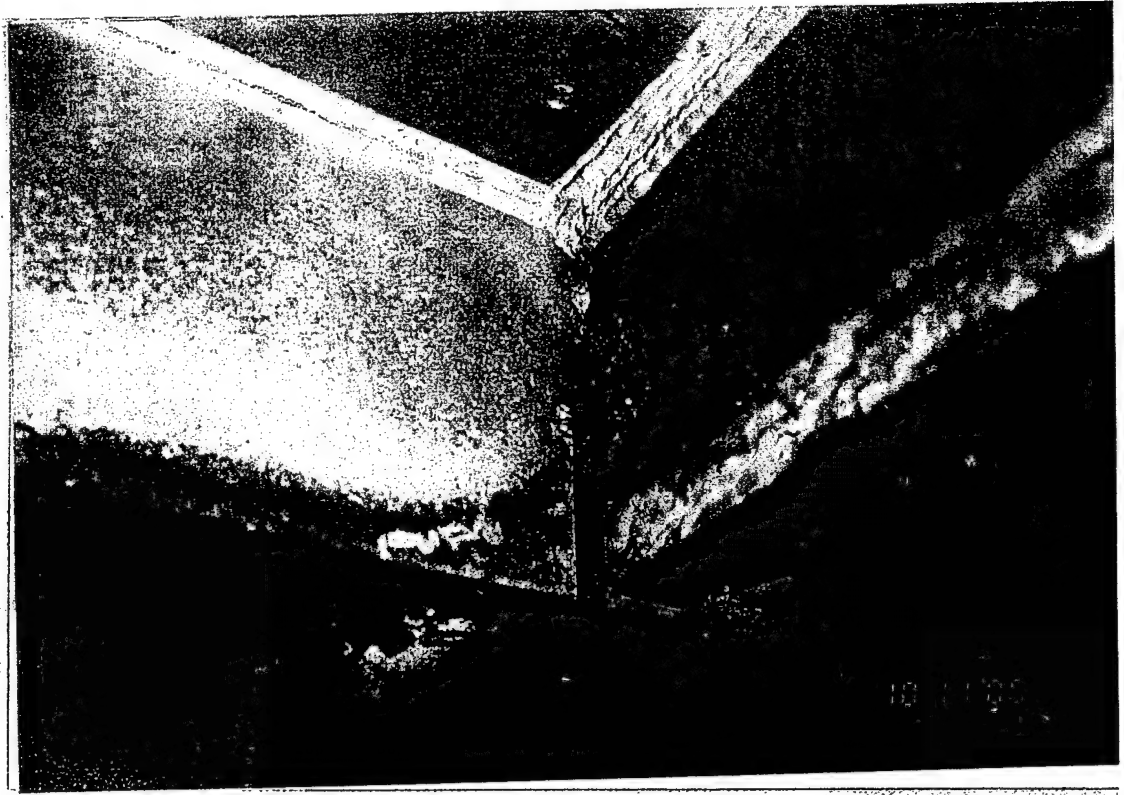
Bottom of bottom horizontal girder  
at radial strut connection and girder  
drain hole. Light corrosion on girder  
web and stiffeners.

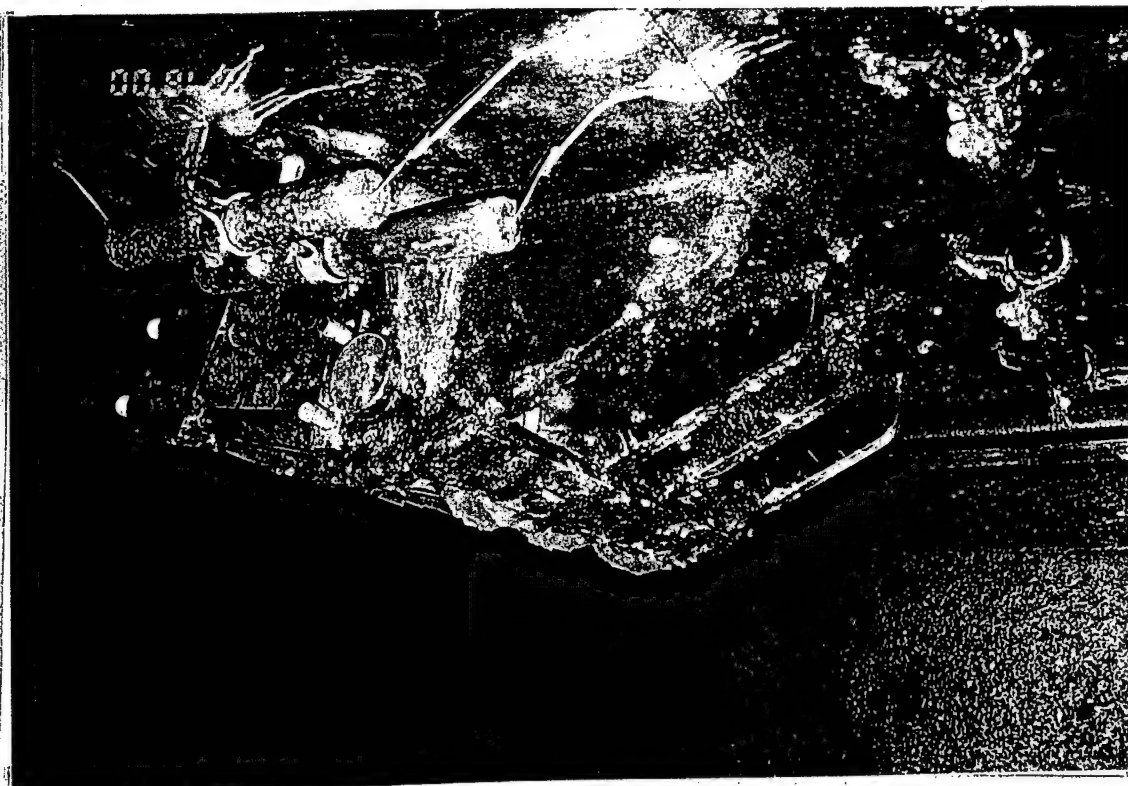
6-26

Gate 6  
Left hoist connection and anodes.  
Light to moderate corrosion on  
lifting lugs and plates. Note: Extra  
anode under hoist connection not  
found on other gates.

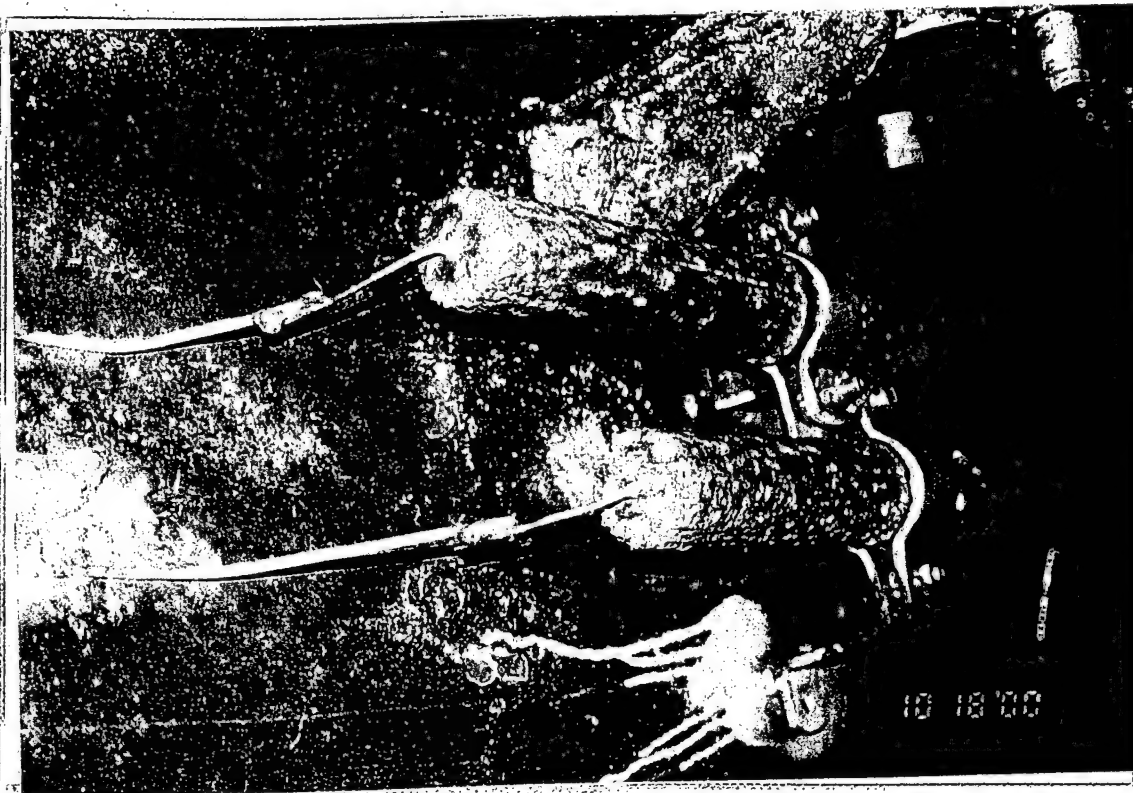
Gate 6  
Hoist connection anodes, typical.

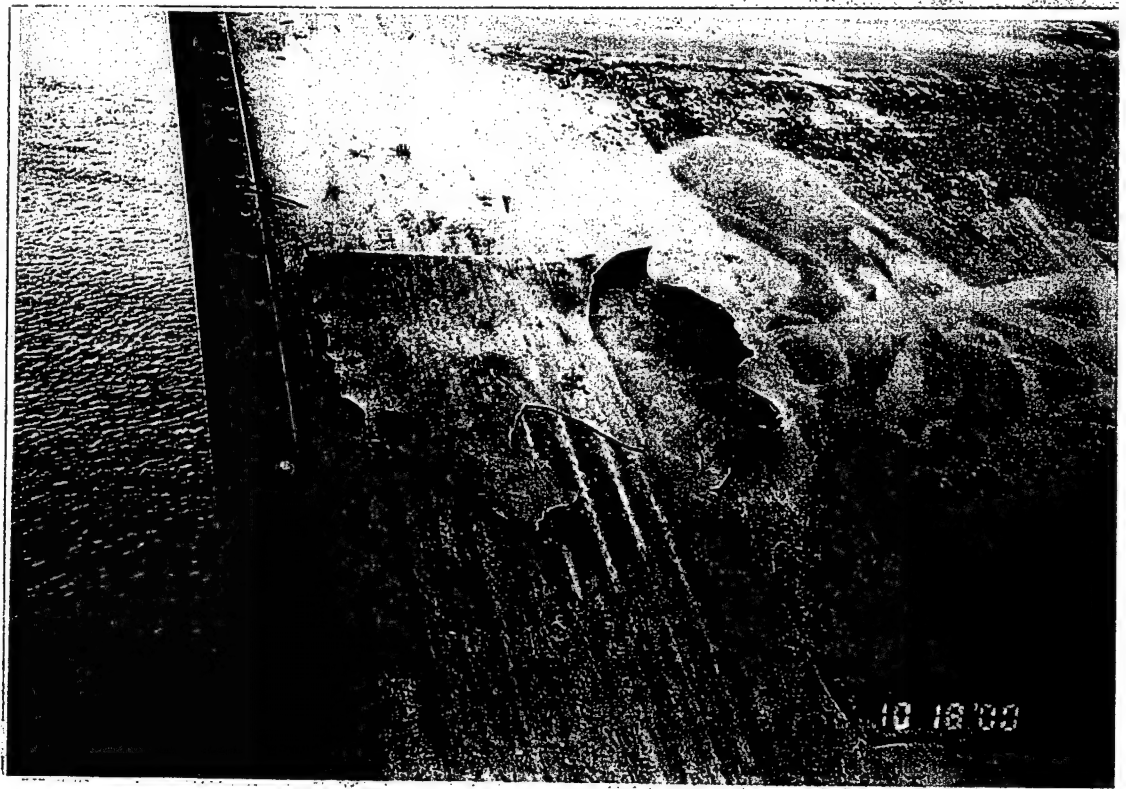
6-37

Gate 6  
Left wear plate. Delaminated vinyl  
coating.

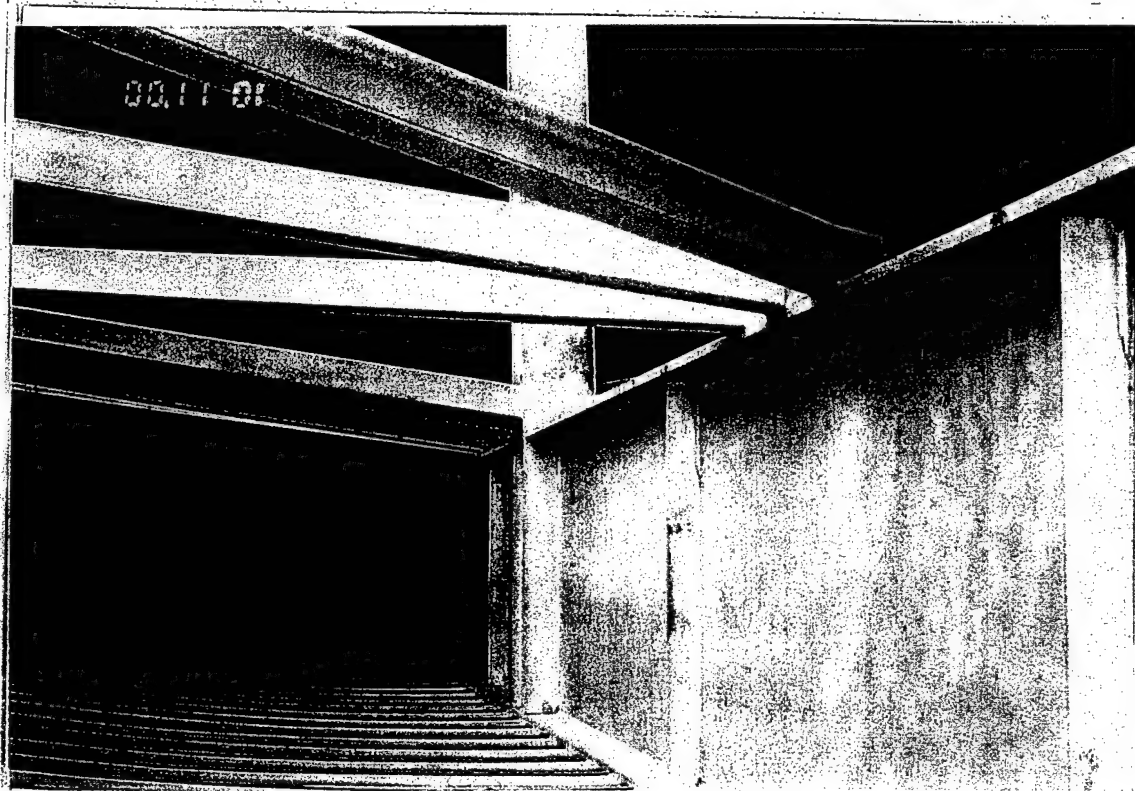
Left frame, Brace A. Light corrosion  
on brace, radial strut and horizontal  
girder.

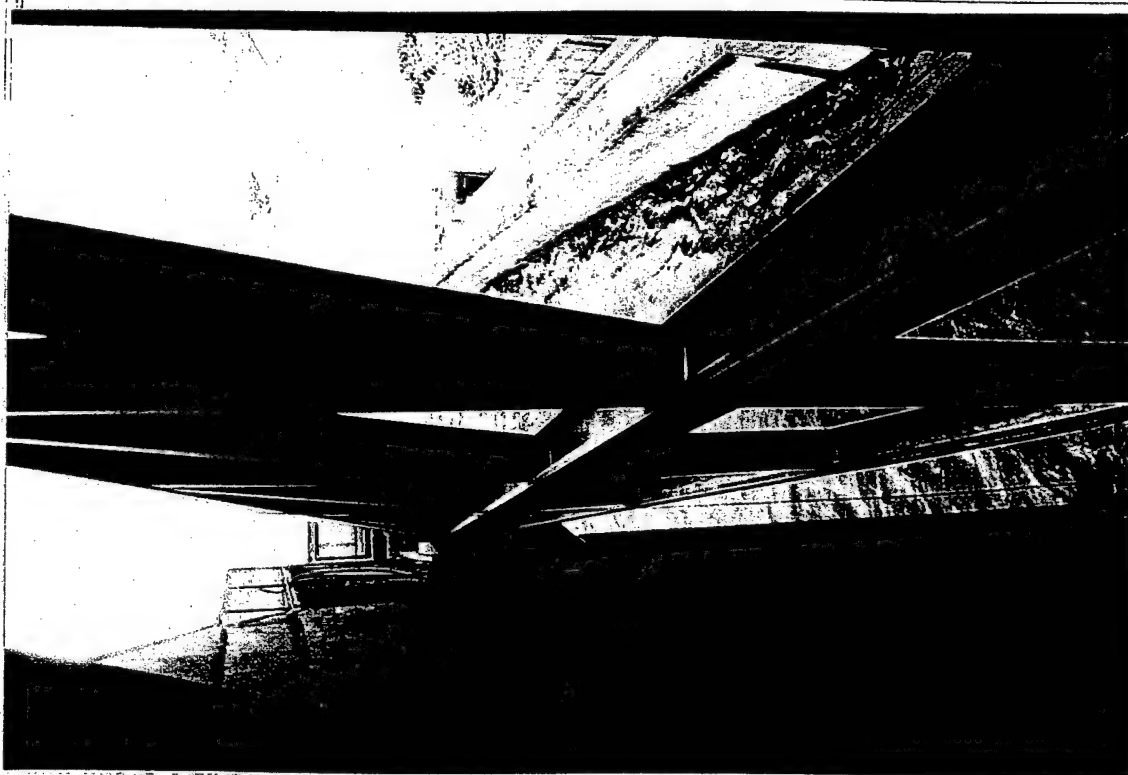
Left frame Brace G. Light corrosion  
on brace, typical.

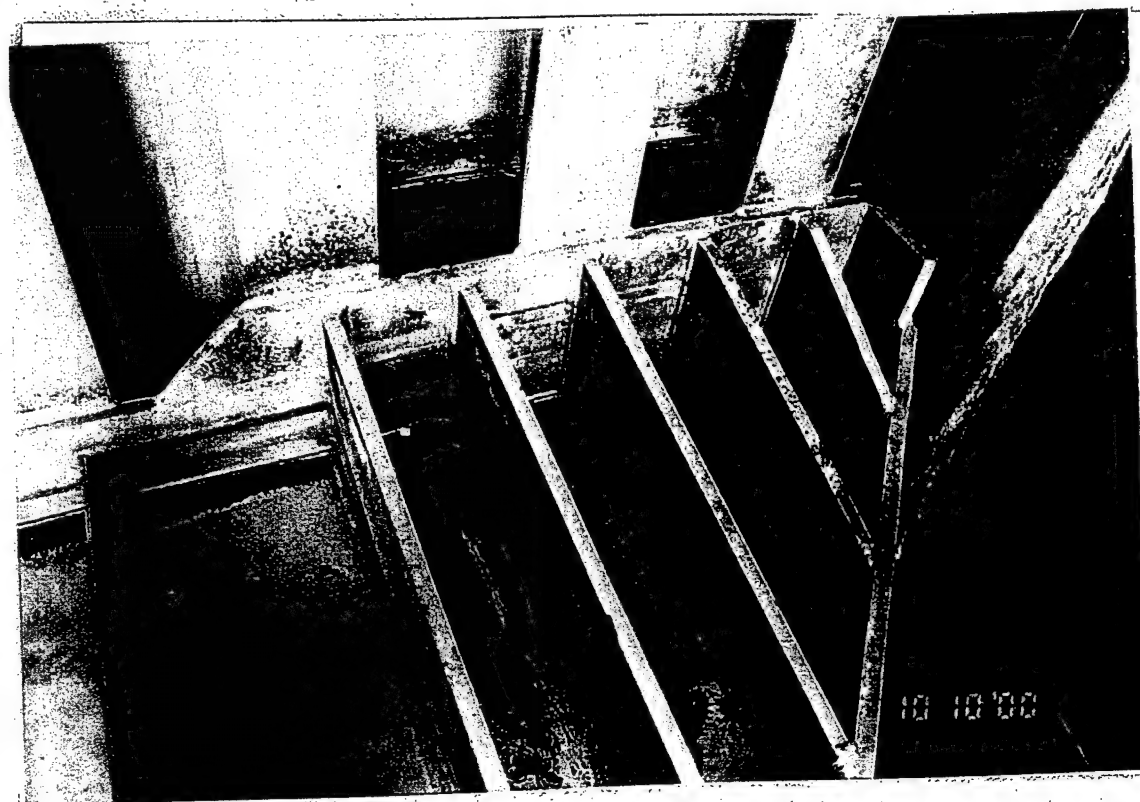
Gate 8  
Downstream surface of skin plate, left  
side of gate above middle horizontal  
girder. Apparent grind marks from  
weld repair.
